Research

Using a washer, disinfectant, lubricator, and dryer to test the effectiveness of cleaning dental handpieces

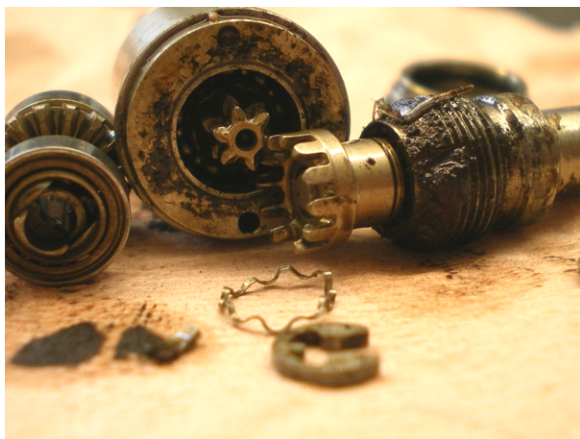
Figure 1: Dismantled HP with inner and outer soiling (Courtesy of Dr. JP Mangion).

phenomenon of backflow occurs.⁵⁻¹¹ Since the head of the HP is running in a septic environment, a retro-contamination and an internal soiling (Figure 1) of the HP occurs, consequently causing external contamination and soiling. This contamination takes place at different levels of the head and body of the HP,¹⁰⁻¹⁷ and the narrow pipes dedicated to bring air and water to the dynamic instrument.^{18,19}

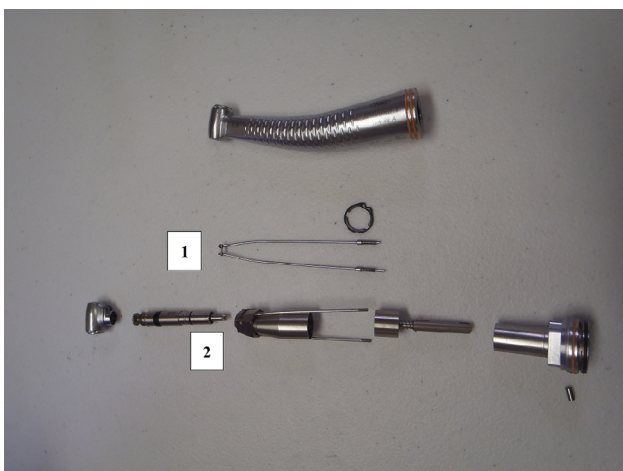
Figure 2: Dismantle of the HP.

1. Dismantle the HP (Figure 2).
2. Stain the outside (body of the HP) and inside (air/water pipes, gears) using Soil Test[®]. Also, stain the load racks (block support for the HP, sides of the tank). Soil Test[®] was chosen because of the good adaptability of the form in which it is presented to the protocol that is described, and its adequacy with biological fouling.⁴⁰
The head of the HP is stained using a Soil Test[®] syringe. The air/water pipes are stained using a Soil Test[®] syringe whose mouthpiece is suitable for their diameter. The pressure on the plunger of the syringe will be made until the Soil Test[®] comes out by the other side of the pipe.

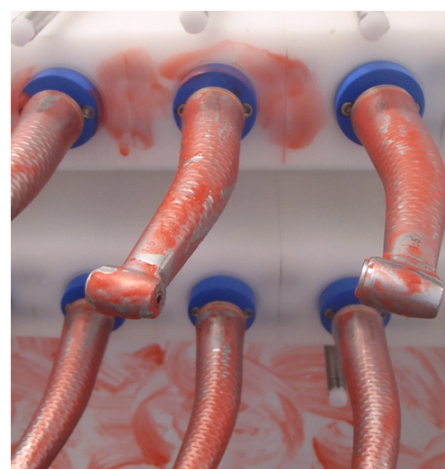
Figure 3: Connection of the soiled HP in the automaton. Soiled load racks and tank sides.

3. Reassemble the HP.
4. Connect the HP in the automaton (Figure 3), and run a cycle with inactivation of the disinfection phase (as specified in the standard NF EN ISO 15883-1 for washing tests).³⁹

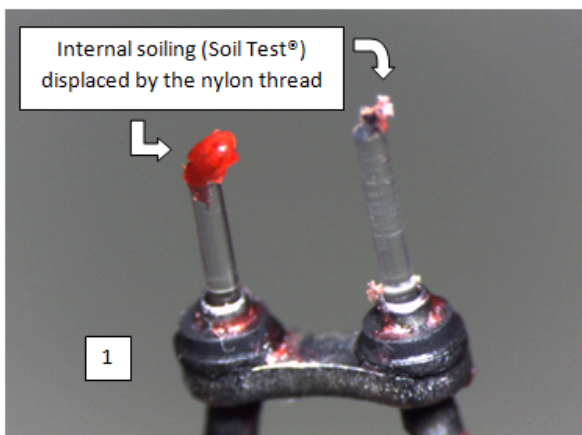
Figure 4: Highlighted interest of pushing a nylon thread through the air/water pipes.

1. The control tests confirm the presence of Soil Test® in the air/water pipes and validate the relevance of pushing the nylon thread through these, because the thread highlights the internal staining of these pipes (Figure 4).
2. The control test on the HP stained during a normal use and treated manually in routine shows residues inside the head of the HP (Figure1) and the air/water pipes. Ninhydrin tests have been performed by swabbing the thread in both situations, and the results were positive (turning to purple) (Table 1).

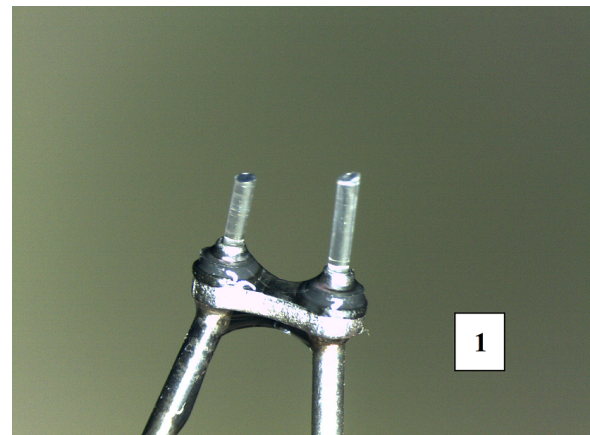
Figure 5: Highlighted cleanliness of the air/water pipes of the HP.

The nylon thread in the pipes showed no deposit on the thread itself, or on the plate over which it was conducted. Ninhydrin tests were performed on the nylon threads, and the results were negative (Table 1).

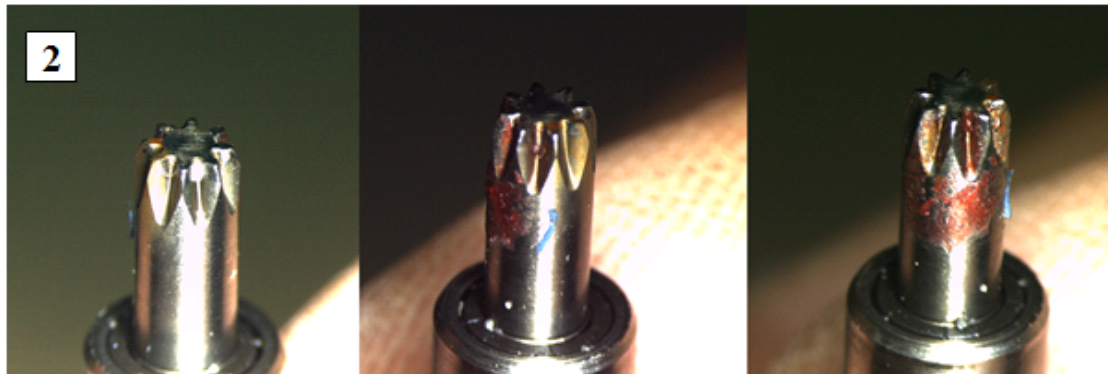
Figure 6: Highlighted soiling on the half of the same gear, due to the non-internal rotation of the HP.

After dismantling the HP, the areas likely to be soiled in a usual dental surgeon’s practice appeared to be clean on the 4 HP for which the motor worked properly. The nylon thread in the pipes showed neither deposit on the thread itself nor on the plate over which it was conducted (Figure 5). Ninhydrin tests were performed on these soiless surfaces, and the results were negative. Concerning the 2 HP which had not been put into an internal rotation, a residual soiling was apparent on the half of the surface of one gear, the other half appeared clean (Table 1). This is shown on Figure 6 through the blue marker and demonstrates the importance of the internal rotation of the HP during the cleaning cycle.

The tests also show that it is essential that the HP kept in internal rotation (as it is when they are used by the dental surgeon as he is working in the patient's mouth) during the cleaning process. Indeed, a lack of internal rotation, as it was the case for 2 HP in the first cycle produces an incomplete cleaning because fluids cannot reach all the surfaces.
